## NON-DESTRUCTIVE INVESTIGATIONS: A CASE STUDY OF A CONVENT IN LOMBARDY (ITALY)

*Elisabetta ROSINA*

### ABSTRACT

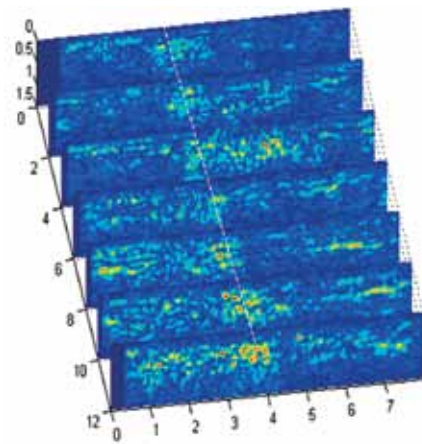
**Fig. 2:** Church of Santa Maria del Lavello. GPR Profiles H1, H2, H3, H4, H5, H6, H7 after the innovative post processing phase (Courtesy of Valle, L. Zanzi, G. Lenzi).

use of an algorithm based on time-space migration and the fundamentals of data pre-processing, allowing the researchers to achieve a good location and identification of the buried ruin.

Particularly, a longitudinal structure is clearly detected in all the 2D profiles across the nave, at 4 metres from the starting point of the profiles (white dotted line in Fig. 2). The structure is 50 cm in magnitude.

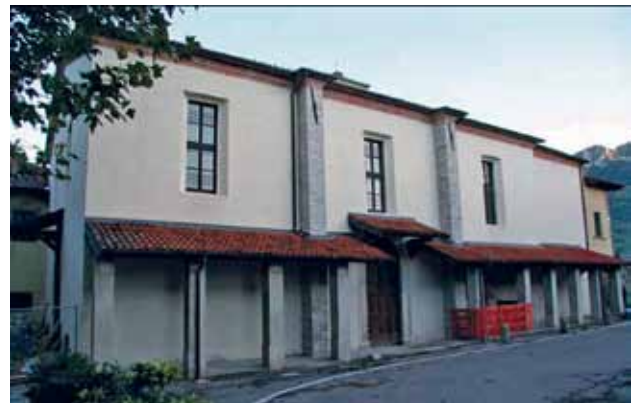
**Fig. 3:** Santa Maria del Lavello, southern side, exterior. **Sl. 3:** Sv. Marija v Lavellu, južna stran, zunanost.

On the southern exterior side, IRT allowed the corner stones within the present masonry to be distinguished, revealing the edge of the first enlargement of the church (see Fig. 3, 4).

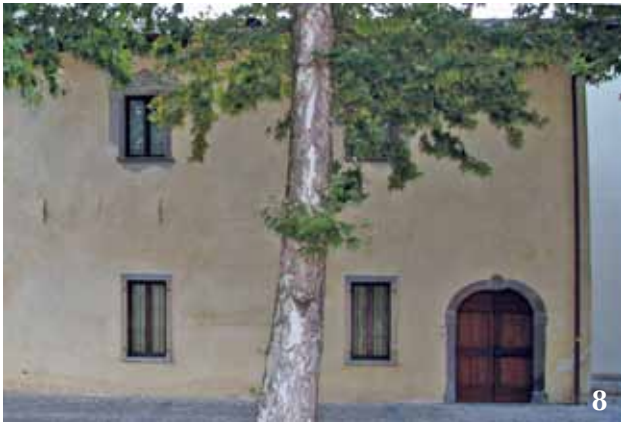
**Fig. 8:** Santa Maria del Lavello, the southern side of the monastery, right part.  
*Sl. 8:* Sv. Marija v Lavellu, južna stran samostana, desni del.

Infrared Thermography allowed many interesting details of this masonry to be discovered. Figs. 7 and 8 show the results.

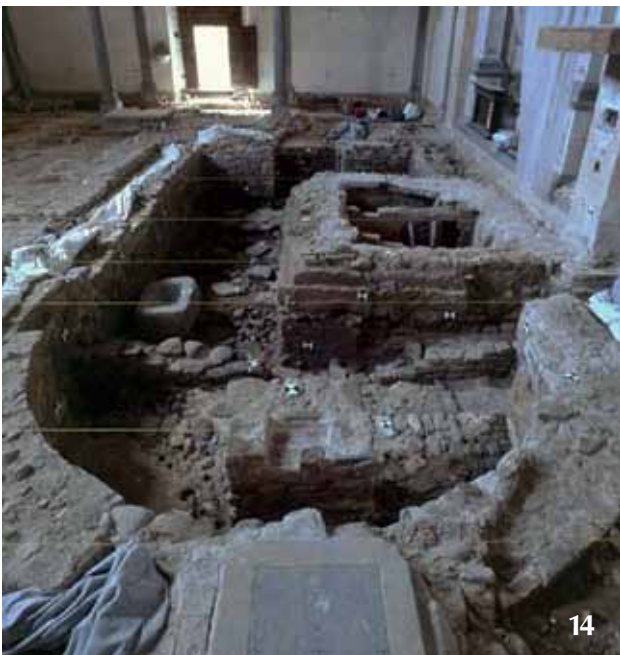
**Fig. 14:** Santa Maria del Lavello, the excavation of the archaeological remains and the location of the target of the topographical survey (Courtesy of G. Cruciani Fabozzi).

Laser scan survey<sup>4</sup> was extremely successful in documenting the archaeological excavation, both in terms of the remains and the morphology of the surrounding land itself (Bonora, 2006; Bonora 2008). As shown in Fig. 14, the

remains and the soil had very irregular geometry and profiles. The project purpose was to keep the remains available for further studies also after the reconstruction of the pavement. The new structure creates a crawling space for the ventilation between the bottom of the excavation and the floor structure. This solution is a “floating floor”, inspired by the constructive concept of the ancient hypocausts. It also takes into account both the needs to insert radiant heating panels and the customer’s request that a significant portion of the archaeological findings remain visible. The floating floor is supported by pillars, whose foundation, size and location were designed to take into account the presence of the remains in order to not put the old structures in contact with the new ones and prevent any possible damage. A part of the new pavement was realized with supporting glass tiles, to allow the view of the ruins. The aim of the survey was to provide the most reliable geometric information to design the foundation of the supporting structure inside the free spaces, where the archaeological findings were not located. The researchers obtained useful measured drawings of the sections of the underground level by “cutting” the cloud of thousands points measured by the laser scan survey (Fig. 15). The final result was a complete documentation of all the findings, their materials and state of conservation (Fig. 16) that allowed the planning of the intervention necessary to restore them and to ensure their optimal conservation in the future. In addition, the documentation was used to support the required information to design the new floor. The floating floor included also the heating plant, a warm water system, and its activation allows the microclimate in the church and underground space to be optimally maintained for the conservation of frescoes, ruins and masonry.

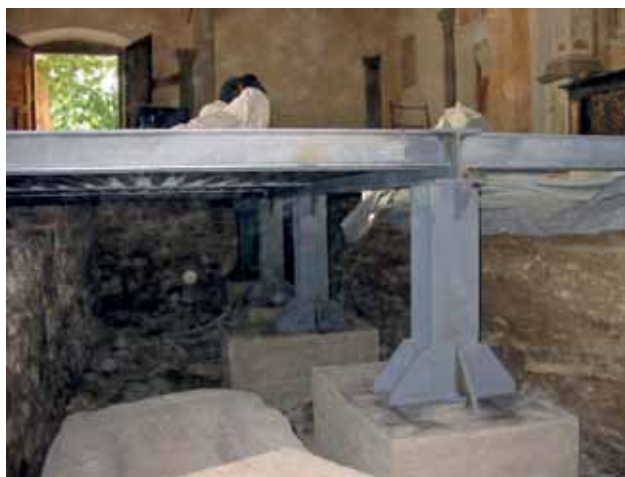
**Fig. 17: Santa Maria del Lavello, the foundation of the pillars in the opaque part of the pavement (Courtesy of G. Suardi).**

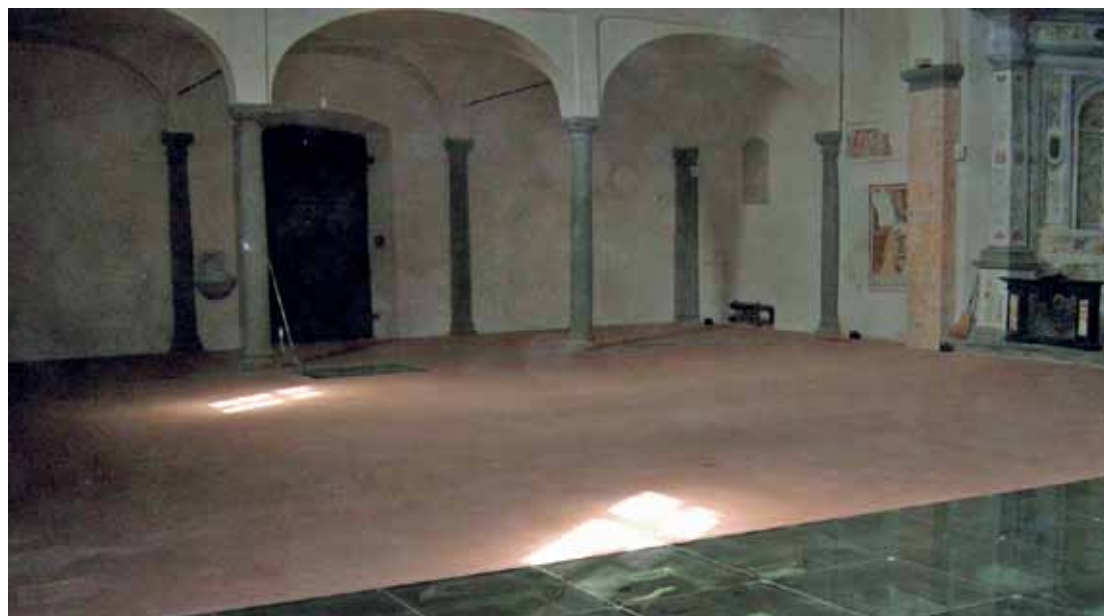
*Fig. 19: Santa Maria del Lavello, the new pavement, partially opaque and partially realized with supporting glass tiles (Courtesy of G. Cruciani Fabozzi).*
